How to create a good SES with less mistakes?

JORGE SÁNCHEZ GALÁN - ES

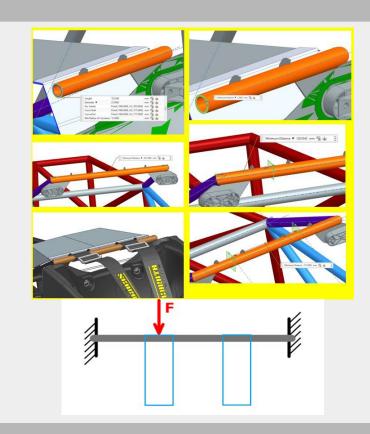
Wrong harness distance on tab *T5.5 Shoulder Harness Bar.*

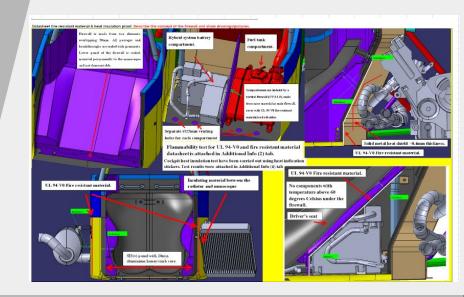
Example of good firewall description

Lack of clear information on firewall lay-up and assembly to the structure.

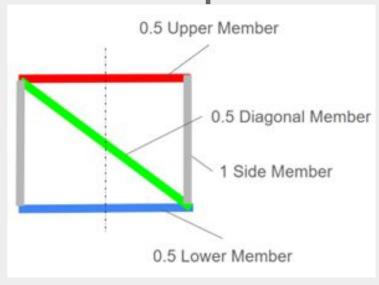
FBH - ACPS/TSPS Rear Example

Incorrect tube count → Typically on FBH, FBHS and (EV only)
ACPS/TSPS Rear

N° of tubes = 2.5

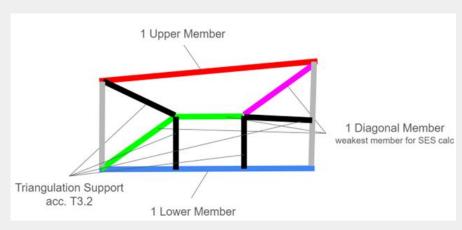
FBHS Examples

N° of tubes = 4

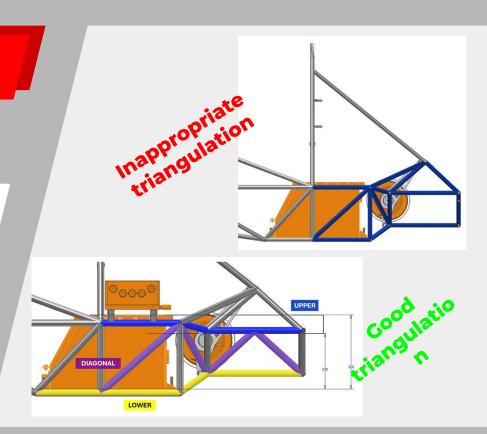
Wrong structure triangulation : FBHS, SIS and (EV only) ACPS/TSPS side.

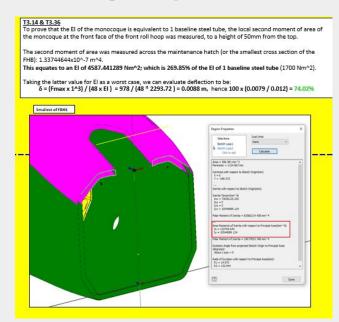
Example of FHB panel strength equivalence

Incorrect calculation of skins inertia for the geometrical probe of panel strength.

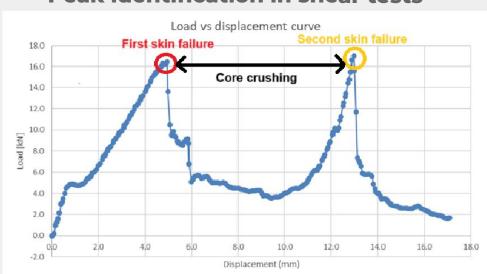
Peak identification in shear tests

Incorrect election of peak values or reference points for gradient calculation in alternative material test results (3 point bending and shear tests).

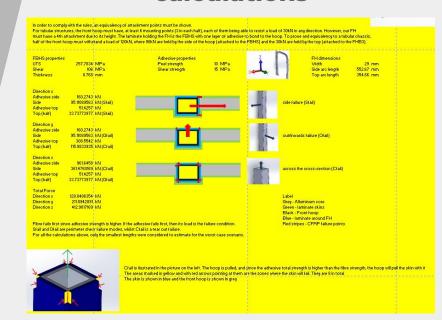
Example of good calculations

Lack of calculation to justify that the laminated FH complies with *T3.9.5* and *T3.9.6*

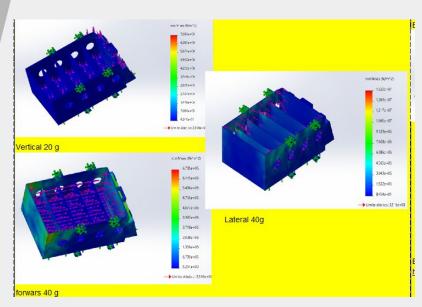
FEM analysis as justification without detailed model explanation

FEM analysis as part of accumulation mechanical strength justification without proper model explanation.

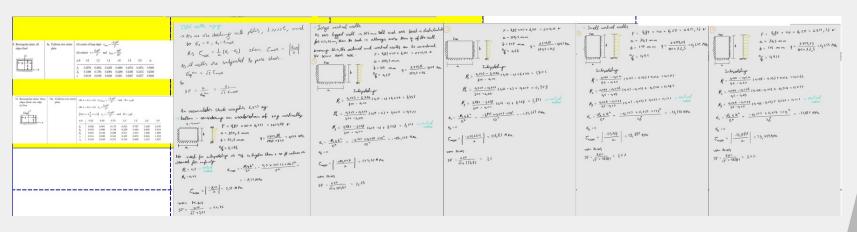
Analytical calculations for different accumulator walls

Missing calculations for some of the components of the accumulator structure → All accumulator structure components must withstand the accelerations marked in *T9.3.1*.

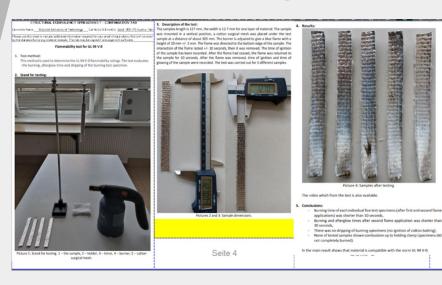
Example of good fire retardant material test report

Incomplete information in the fire retardant material test report (if applicable).
